TS-PIC-96502/9605502S
March 1996

AERIAL PHOTOGRAPHIC ANALYSIS SAM WEINER PROPERTY

Summit County, Ohio

EPA Region 5

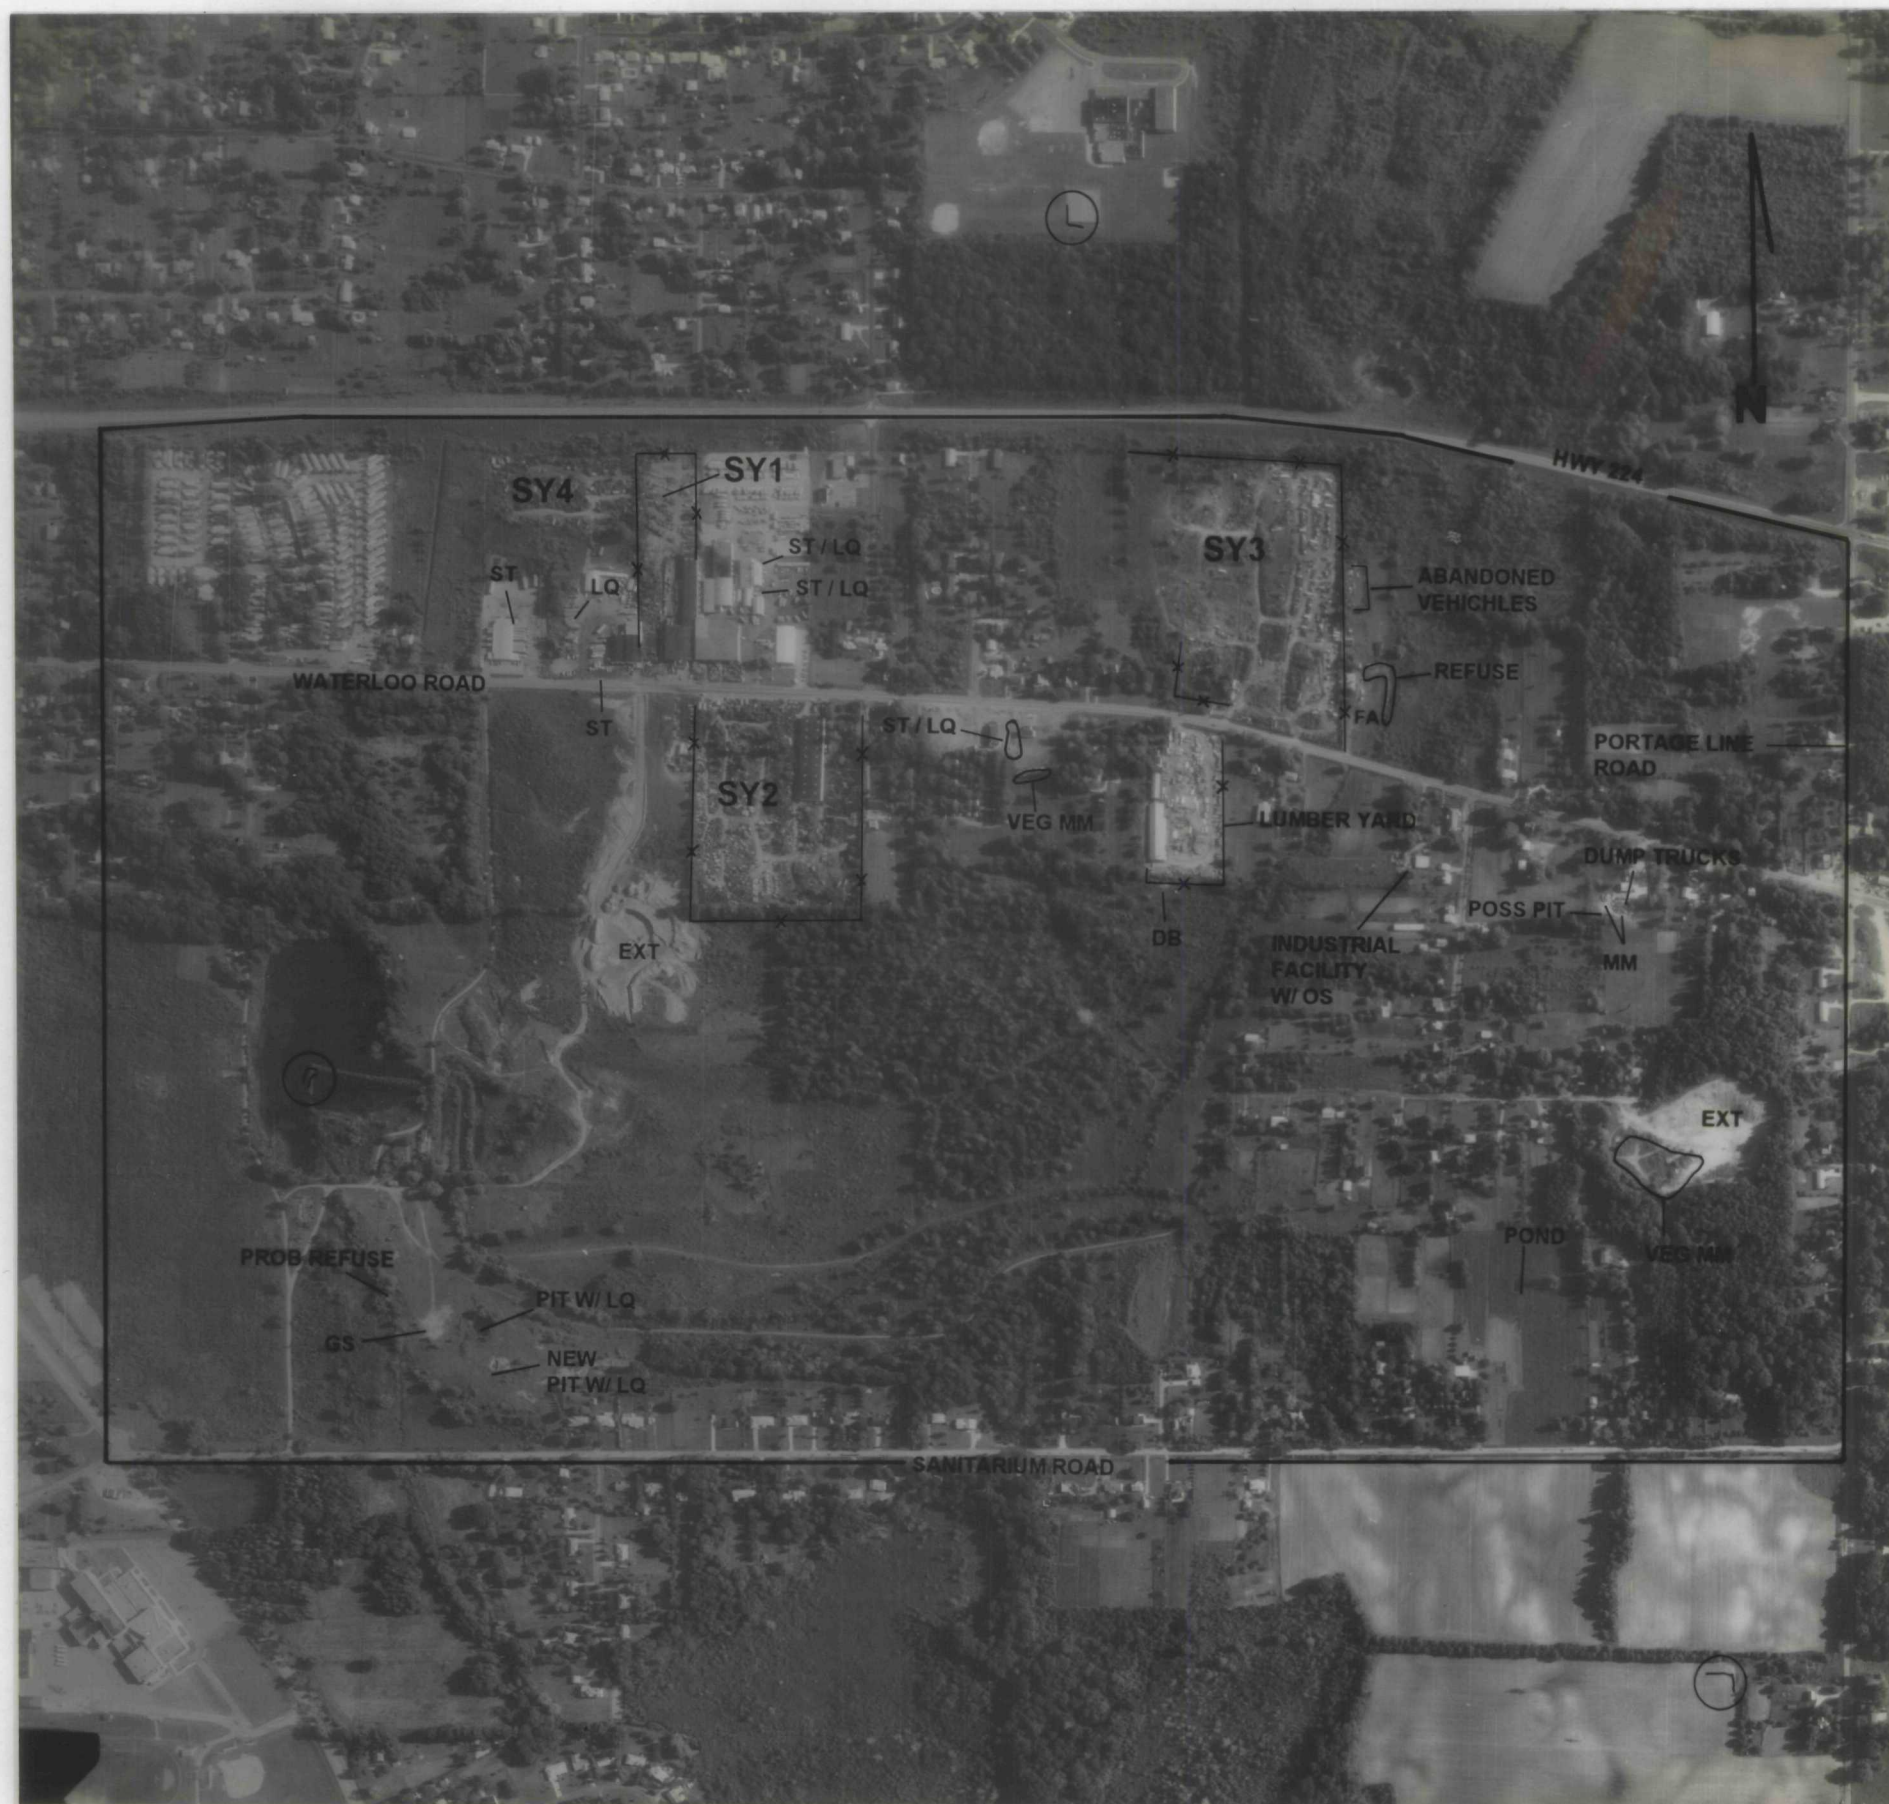
FIGURE 8

The salvage yards remain active; however, SY1 and SY3 have a reduced amount of salvage scrap/debris.

The northern half of SY1 appears to have been graded and some of the the salvage scrap removed and the area reorganized. Areas of staining and liquid are present at the industrial facilities both east and west of SY1. The liquid is present where vehicles are parked and the areas of stain/liquid appear to originate at the buildings.

No changes are observed at SY2. Abandoned vehicles are present east of SY2.

The former mounded material at the fill area east of SY3 has been graded and refuse is present along the edge of the filled area. A group of abandoned vehicles is present north of the fill area. The number of junked vehicles at SY4 has not changed significantly and vegetation has overgrown many of the vehicles in the western half of the yard.

A new extraction area is present southeast of SY2. The extraction operation south of the lake is no longer active; however, a ground scar, the pit with liquid, and a recently excavated pit with liquid are present. Probable refuse which is partially obscured by tree canopy is present where the piled objects/rubble was previously seen.

Other findings include debris present south of the fenced lumber yard, stained/wet ground (WG) and vegetated mounded material at the former truck stop located between the lumber yard and SY2, continued open storage of haphazardly placed equipment and objects at the industrial facility east of the lumber yard. A site with vegetated mounded material, a possible shallow pit and two dump trucks is present east of the aforementioned industrial facility. The probable dump observed farther east in 1974 is obscured by shadows; however, light-toned material or disturbed ground is discernible in the shadows.

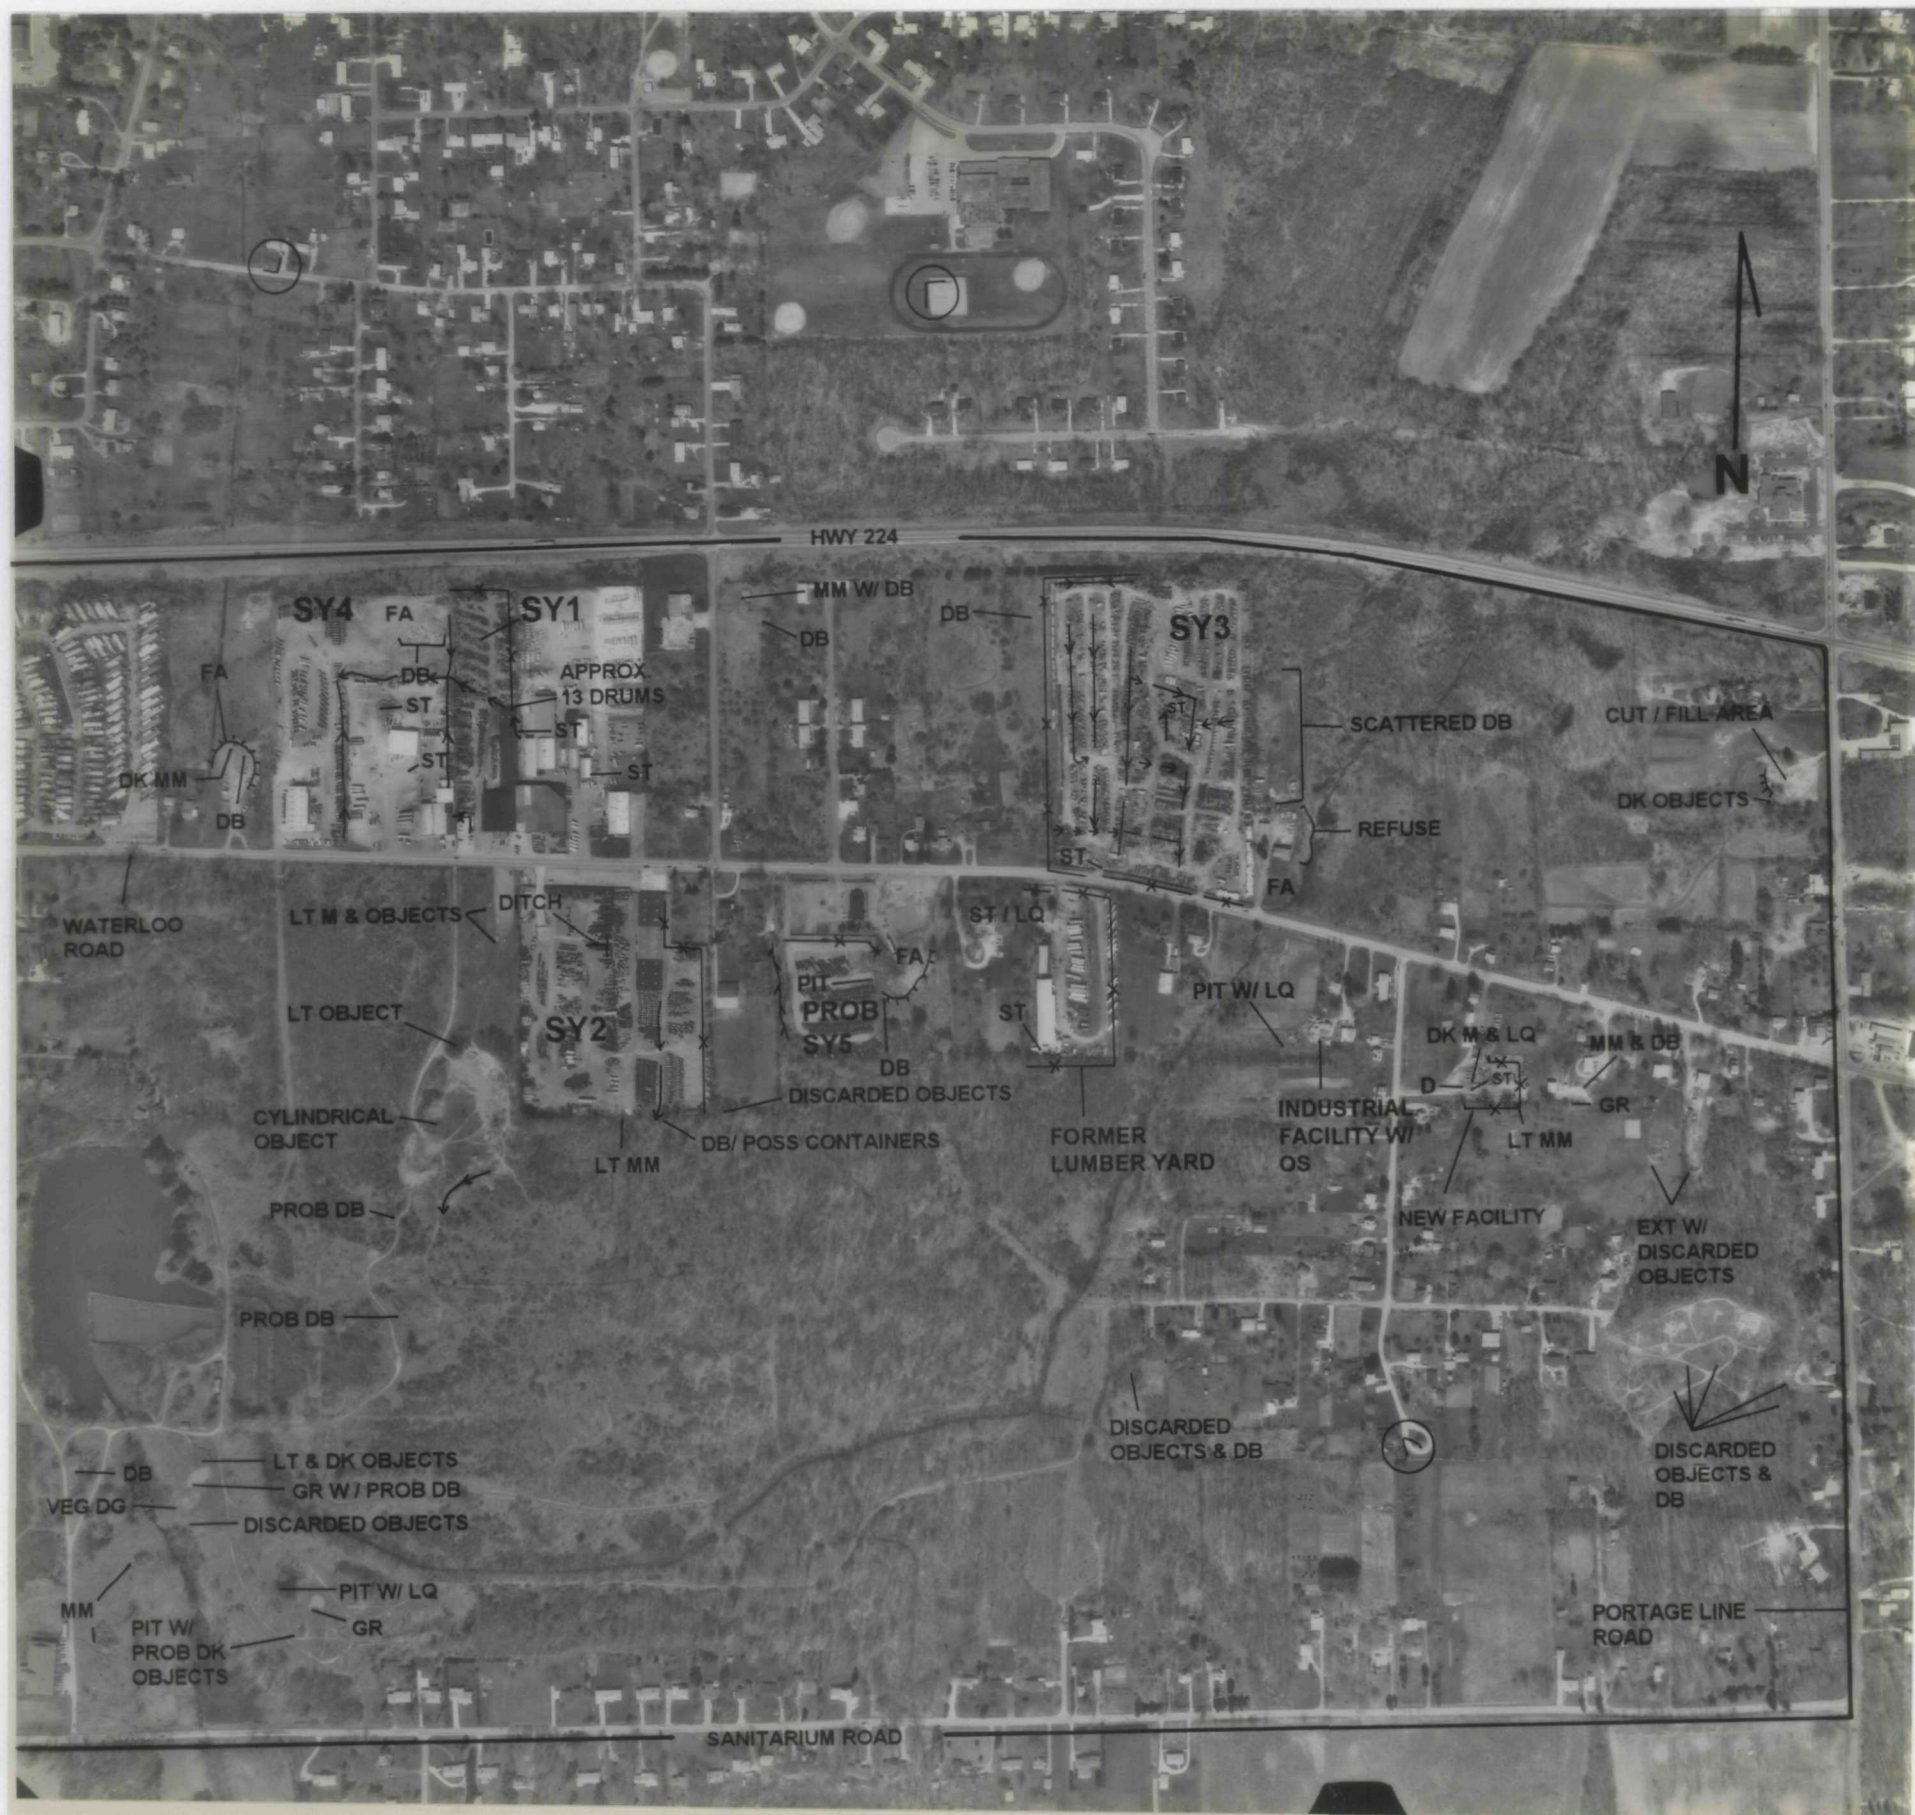
FIGURE 9

All of the salvage yards have been cleaned-up/reorganized and a new probable salvage yard (SY5) is present between SY2 and the former lumber yard. This is the first date of aerial photography where disposal is evident at the now inactive extraction areas within the study area (see Figure 9 for location and descriptions of discarded items).

SY1 has not changed significantly since 1980. Drums (D) are present east of the SY1 fence at the adjacent operation where stains are present near two buildings. The western stain has a flow pattern that extends to a channelized drainage route passing through SY1.

SY2 has been reorganized, graded and consists of vehicles, trailers and salvage parts. A south-flowing channelized drainage route has been made and it extends to a pile of debris, possibly small containers, at the SY2 property line. Probable junked vehicles are present east of SY2 at the south end of the adjacent property.

SY3 has been reorganized, regraded and new channelized drainage routes added. The former fenced area with scrap/debris is no longer present. Scattered debris and refuse are present east of SY3 and a building (not annotated) has been constructed atop the fill area.

It appears as though all the former junked vehicles at SY4 were removed, the area graded and the northeastern portion filled. Vehicle parking is concentrated in the western portion of the yard. Another fill area is present west of the expanded SY4 facility. Mounds of dark-toned material and debris are present along the edge and on the surface of the fill area.

The probable SY5 facility is fenced on its north side and bound by an earthen berm on its west side. A shallow square pit is present in the northeast corner of the yard. A fill area is present to the east and two trailers are parked atop the filled area.

Staining/liquid is present at the entrance to the former lumber yard , which appears to have been converted to a shipping and receiving facility. Another stain is present near the south end of the onsite building.

The building at the industrial facility to the east of the shipping/ receiving facility has been expanded and may still be under construction, as excavated and graded areas are present along the western and southern sides of the expanded building (not annotated). Open storage of haphazardly placed equipment and objects continues. A pit with liquid and an adjacent pile of the excavated material (not annotated) is present west of the facility building and open storage area.

A new fenced facility is located east of the aforementioned industrial facility. A mound of light-toned material, parked vehicles and flatbed trailers (neither annotated) are present in the fenced yard. A stain and a mound of dark-toned material with a pool of liquid at its base are adjacent to five drums at the west end of the facility.

Further east, a graded area, mounded materials, and scattered piles of debris are present where the possible pit, mounded materials and dump trucks were observed in 1980.

Discarded objects are present within two extracted areas southeast of the aforementioned facilities. The eastern extraction area corresponds to the probable dump identified in 1974.
